Report of Investigation 2021-1D Alakanuk

COASTAL FLOOD IMPACT ASSESSMENTS FOR ALASKA COMMUNITIES—ALAKANUK

Richard M. Buzard, Jacquelyn R. Overbeck, Katie Y. Miller, and Jessica E. Christian

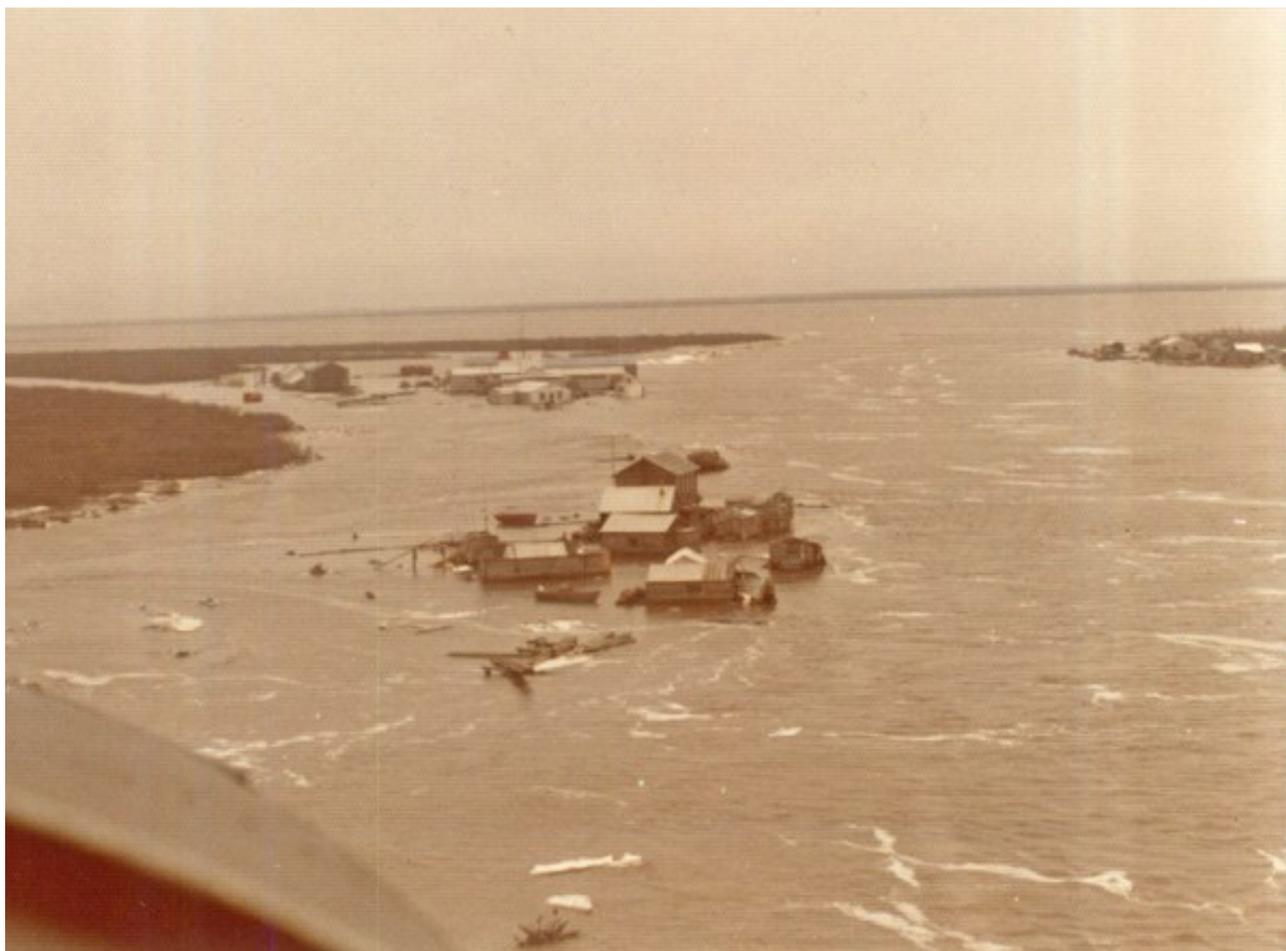
Photo from airplane looking at major flooding of the Alakanuk old village site on the north shore of Alakanuk Pass Slough. The photo looks east towards the Yukon River during the May 1972 ice jam flood. The old cannery is in the background to the left and the old Native Corporation Store is on the south bank to the right. Photo: Alaska Village Electric Cooperative (AVEC).

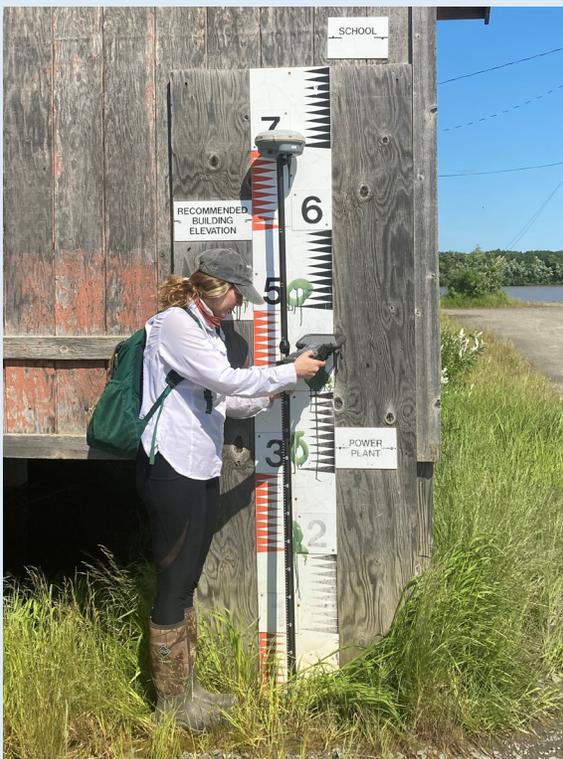
Figure 3. Flood staff on old city office. The 0 mark is 6.2 ft MHHW. The posted recommended building height is 12.3 ft MHHW.

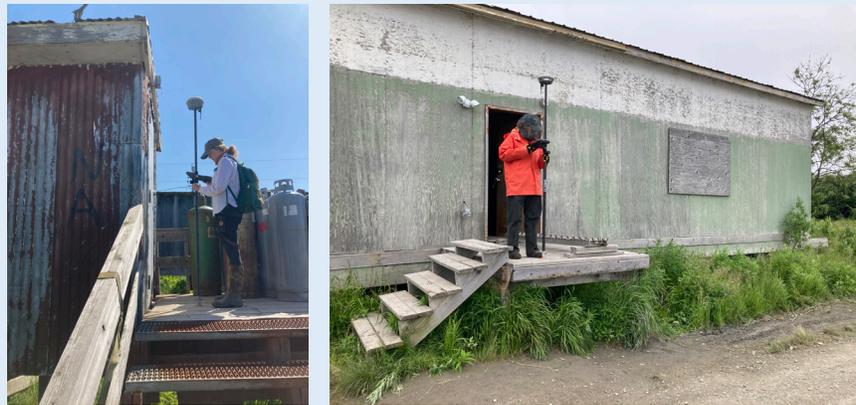
Figure 4. (Left) DGGS GNSS measurement at old Native Corporation Store porch. (Right) DGGS GNSS measurement at Jorgenson's Store porch near river. This photo shows buildings during a DGGS survey, however, first-floor measurements used in this assessment were collected by CRW Engineering Group, LLC. Both surveys agree to within 0.1 ft.

The old Native Corporation Store first floor height is 13.0 ± 0.1 ft MHHW (CRW, unpub. data, 2021; fig. 4; table B1). Of remaining structures that existed in 1971 and have not been raised, the Jorgenson's Store is the highest with a first-floor height of 11.1 ± 0.1 ft MHHW (CRW, unpub. data, 2021; fig. 4; table B1). Flooding of 4.0 ± 1.0 ft above the riverbank would reach 11.6 ± 2.1 ft MHHW, exceeding the 1952 flood. Considering water height ranged ± 1.0 ft and reportedly reached the Jorgenson's Store first floor but did not exceed the 1952 flood, we use the store floor and water range to estimate the June 1971 flood reached 11.1 ± 1.0 ft MHHW. The old runway was improved between 1971 and the 2016 DTM so we cannot use its height.

Water did not exceed 11.1 ± 0.1 ft MHHW, the first-floor height of Jorgenson's Store (CRW, unpub. data, 2021; fig. 4; table B1). Water reached 2 to 5 ft deep depending on the part of town, which is 1 ft below the range of the 1952 flood. USACE (1989) estimates "zero damage" is 3 ft below the 1952 flood, 8.3 ± 1.0 ft MHHW. Water reaching 2.0 ± 1.0 ft above this height would flood residences with 1 to 3 ft of water while remaining 1 ft lower than the 1952 flood and not flooding Jorgenson's Store. We use the upper-lower bounds method to estimate the May 1972 flood reached 10.1 ± 1.1 ft MHHW (table 6).

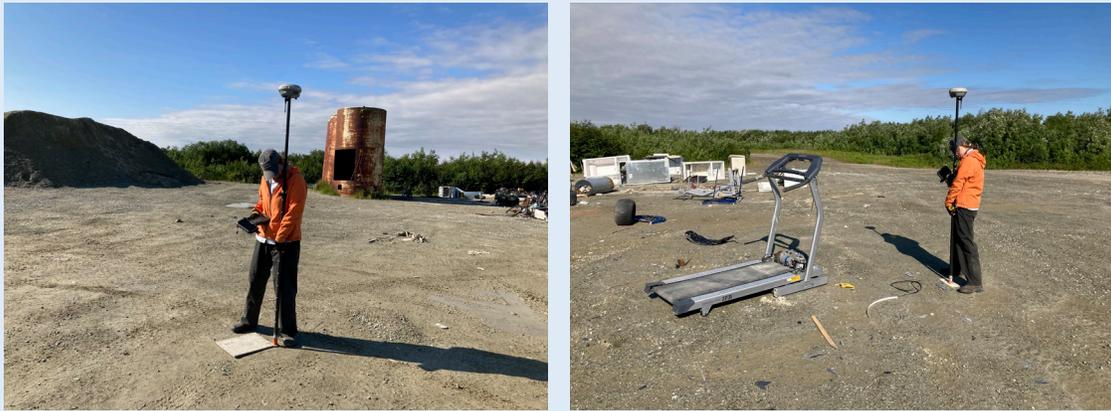
Figure 9. Elevation measurements taken at the old airport apron.

The old runway appears to have no renovations between 1992 and 2006 (within this period it was replaced by the new runway), so measurements on the DTM should reflect elevations at the time. The runway is 12.2 ± 1.9 ft MHHW (fig. 8), and the apron is 9.1 ± 0.5 ft MHHW (fig. 9; table B2).

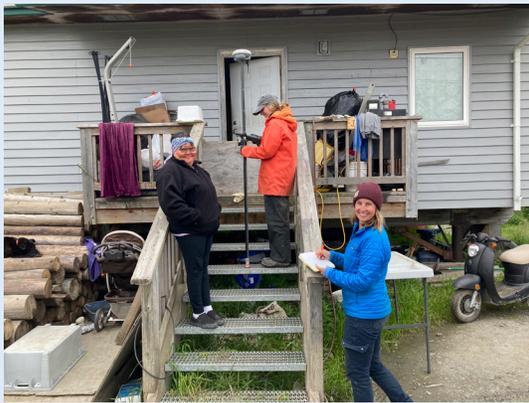
Figure 10. Elevation measurement taken at porch step reached by the May 1991 flood.

The community of Alakanuk (oral commun., 2021) identified a porch step where water peaked at 8.1 ± 0.1 ft MHHW (fig. 10), indicating water was higher towards the Yukon River. As of 2021, the eight lowest structures have a first floor height below 9.0 ft MHHW (fig. B2). We use the observed height at the residence and the apron to estimate the May 1991 flood reached 8.8 ± 0.8 ft MHHW (table 9). This is high enough to flood a few structures and cause the other observed impacts without inundating the old runway.

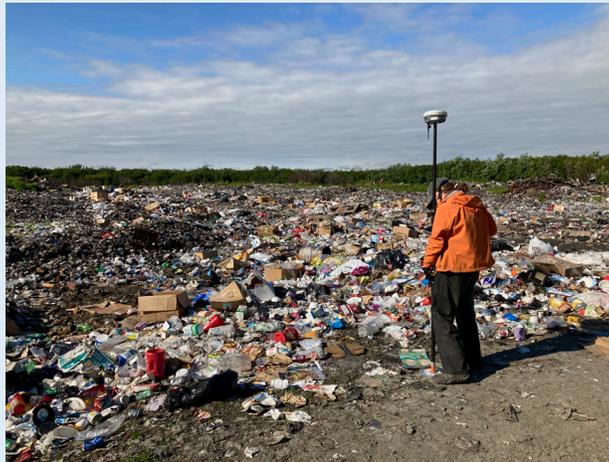
Figure 11. GNSS measurement at the landfill entrance.

The May 2006 ice jam reached the insulation of multiple homes and flooded the wastewater lagoon, landfill, and part of the airport apron (NOAA, 2006; community of Alakanuk, oral commun., 2021). The flood reached at least to the wastewater lagoon berm, 8.5 ± 1.3 ft MHHW (fig. B4). The flood peaked near the mean old runway apron height of 9.1 ± 0.5 ft MHHW (fig. 9; table B2). Floods reaching in this range can cause the described impacts, including flooding of the landfill, 6.8 ± 1.0 ft MHHW (table B2, fig. 11). We estimate the May 2006 flood reached 8.4 ± 1.2 ft MHHW (table 11).

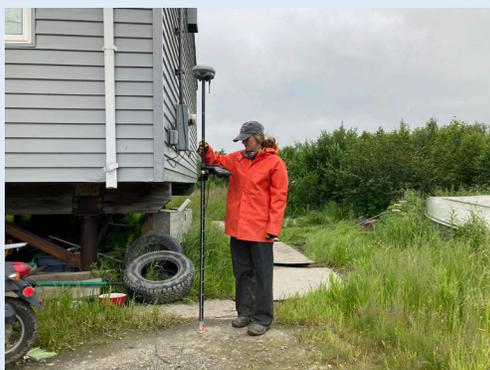
Figure 12. GNSS measurement of ground near house where water reached 2 ft deep during the November 2011 flood.

The November 2011 storm caused major flooding across western Alaska, but Alakanuk experienced minor flooding (NOAA, 2011). The river is typically frozen over in November, but the fall was unusually warm and the river had no ice (community of Alakanuk, oral commun., 2021). Water reached 2.0 ± 0.5 ft above the ground at one residence on the airport road (fig. 12; table B2). We estimate the November 2011 flood reached 7.4 ± 0.5 ft MHHW.
